High-Risk Flood Control Dams on Difficult Soil Foundations

HIGH-RISK FLOOD CONTROL DAMS ON DIFFICULT SOIL FOUNDATIONS

Addicks and Barker Dams are two flood risk management structures owned and operated by the U.S. Army Corps of Engineers (USACE) and recently classified as extremely high risk. These dams were built in the 1940's in west Houston, Texas, upstream of a densely populated metropolitan area. The dams consist of 11 and 13 miles of rolled earth embankments, outlet structures with five barrel conduits, and uncontrolled spillways at both ends of both dams. The original design of both dams provided for four of the five outlet conduit barrels to be ungated, permitting a combined uncontrolled discharge from both dams of 15,700 cubic feet per second into Buffalo Bayou. Due to urban development throughout the 1940s and 50s, all conduit barrels of both dams were gated by 1963 to allow restricted discharge flows into Buffalo Bayou during normal operating conditions.

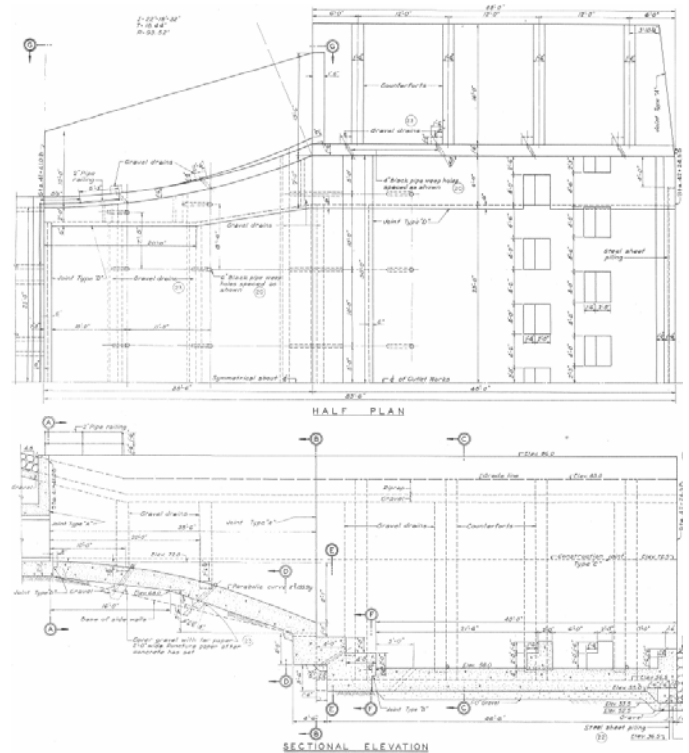
Figure 10 - Addicks Dam Spillway and Stilling Basin Slabs

Spillway Cavity Repair, Addicks Dam. In 1968 a large cavity was discovered under the southeast cantilever wall base and the parabolic spillway slab. The cavity was assumed to have

been caused by flow into upper weep holes, expansion joints, and cracks. The foundation material was apparently washed out through weep holes at the base of the spillway slab due to the lack of a properly installed filter preventing the foundation materials from exiting the structure. Investigations revealed that the cavity was extended under about two-thirds of the spillway slab and had a maximum depth of about 10 feet. Samples obtained from the bottom of the cavity through the weep holes revealed that the soils under the spillway slab range from sandy clay to silty sand with some sandy silt and clayey silt. Observations during these investigations revealed that the silty and sandy silt were readily transported by the flowing water and that the clay was being eroded by the flow of water. Figure 10 shows the spillway and stilling basin slabs of the original installation for Addicks dam. Expansion joint material between the spillway slab and cantilevered walls was replaced and the small crack in the toe of the east cantilevered wall was repaired. Figure 11 presents the typical arrangement of the expansion joints between the spillway slab and wall. Well screens were placed in the lower weep holes, and filter sand was flushed through the upper weep holes and some intermediate holes that had been drilled for the repair. After placement of the filter sand, the intermediate holes were plugged and relief valves were inserted into the upper weep holes.

adding weep holes in the stilling basin slab, adding relief wells, and backfilling beneath the spillway slab. Additional sealing, inspection and repair to relief wells, and additional replacement of filter sand, and repair of spalled concrete areas were completed in 1989.

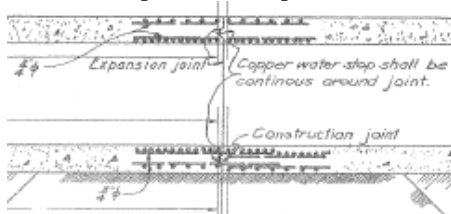
Figure 16 - Typical Conduit Joints for Barker Dam

Repairs to Outlet Works, Barker Dam. Figure 16 shows the typical conduit joints at the Barker dam. Inspections of the joints also indicated repairs were required. Repairs to the outlet works in 1982 consisted of sealing conduit joints and installing additional weep holes and screens in the stilling basin slab. In 1989, additional repairs included sealing joints, inspection and repair of relief wells, repair of spalled concrete areas, and repair of stone protection.

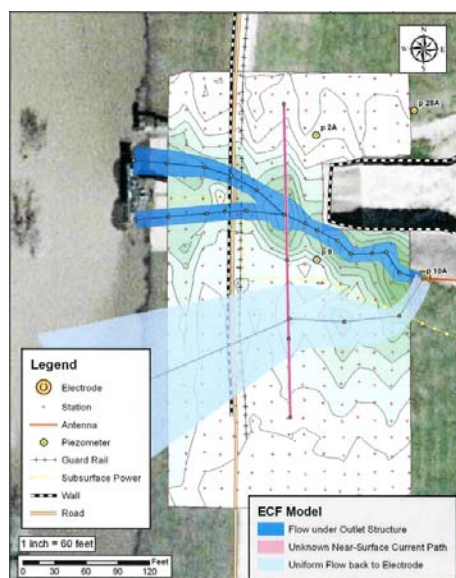
Figure 20 - Electric Current Flow Model, Barker Dam

Electric Potential Survey. In September 2008, a geophysical investigation using electric potential technology was conducted to study the seepage flow potential at the outlet works of both dams. The investigation concluded that seepage was believed to be flowing beneath the outfall conduits at Barker Dam. Figure 20 presents the results of this investigation at Barker Dam. The investigation also indicated that there was more mass flow and not a significant preferential seepage flow paths identified at the outfall of Addicks Dam.

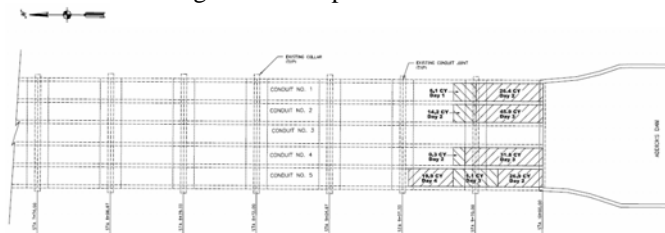
Figure 21- Polyurethane Material Grout Volume, Addicks

Phase I Polyurethane Grouting. In May 2009, a near record high pool occurred at Addicks and Barker Dams. Due to the suspect of voids beneath the conduits of the outlet works from previously investigations, an urgent and compelling contract was executed to fill voids beneath the conduits. Because of the high pool and the anticipated seepage flows, it was believed that cement grout would not be effective. With this in mind, a hydro-insensitive polyurethane material was recommended

for the grouting. Figures 21 and 22 show the grout volume fill recorded during the operations at both dams.

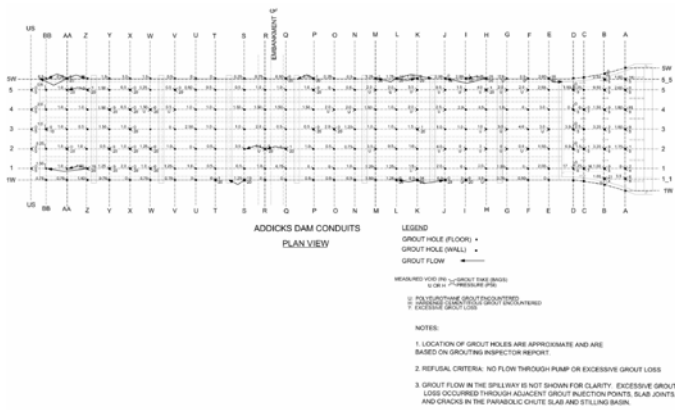
Figure 23 - Phase II Cement Grout Records, Addicks Dam

Phase II Voids Filling. Following the baseline risk assessment, USACE decided to follow up the polyurethane grouting with Phase II cement grouting to ensure all voids were effectively filled. In March 2010, Phase II cement grouting was initiated to fill all voids that might not have been filled during Phase I as well as additional voids that had been created since May 2009. Grout holes were drilled in the floor of the conduits the spillway and stilling basin as well as the outer walls of structure. Prior to initiation of grouting operations, the holes were probed to try and ascertain the depth of void beneath/behind the concrete. Voids were detected beneath the conduits, the spillway and the stilling basin. Figures 23 and 24 show the measured voids and the grout take volume beneath the structure during the Phase II grouting operations.

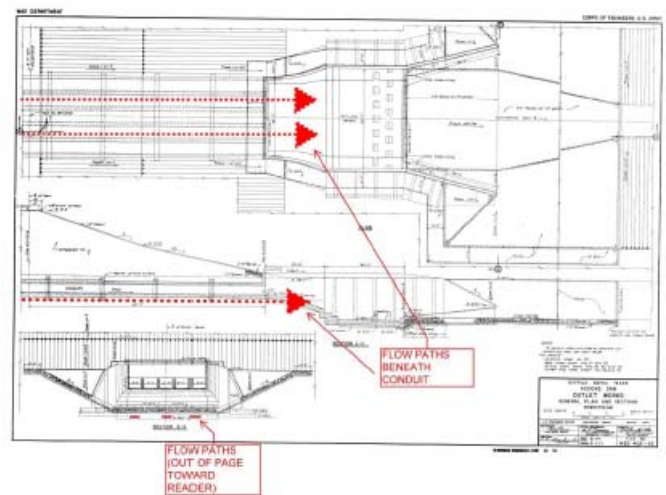
Figure 25 – Plan and Profile View of PFM 1

PFM 1 – Seepage flow along or beneath outlet works structure due to low stress areas leads to headcut erosion beneath outlet works structure. This failure mode is known to be credible because of the voids were discovered beneath the structures in 2009 and 2019 for both Addicks and Barker Dams.

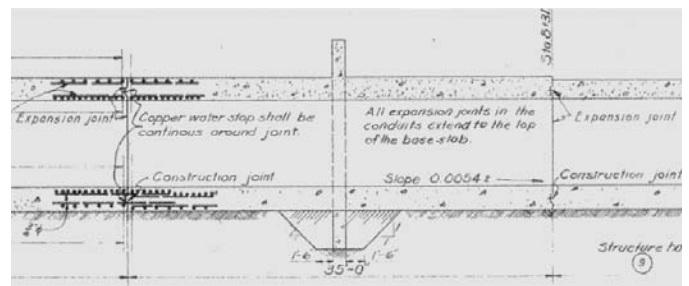
Figure 26 – Typical Conduit Joint Plan at Barker Dam

PFM 21 – Hydraulic pressure in the conduit exceeds pressure outside the conduit which leads to seepage through conduits joints and erosion along conduits. This PFM is credible because of the lack of effective waterstops in the joints on the conduits at both dams.

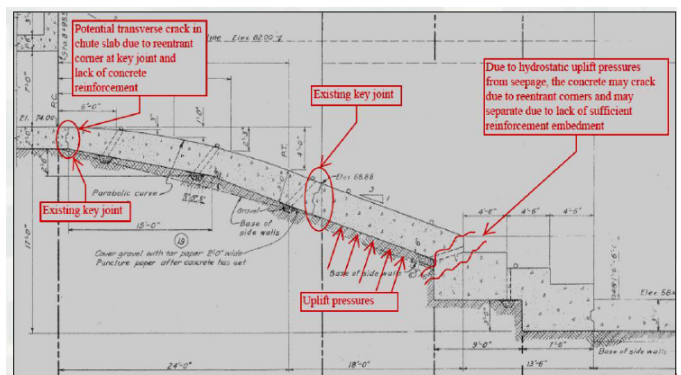
Figure 27 – Potential Uplift Pressure on Parabolic Chute Slab

PFM 22/23 – Instability of the outlet works parabolic slab and stilling basin training walls due to uplift caused by excessive seepage and/or high tailwater. The uplift relief drains that were beneath the spillway and stilling basin were grouted during the 2010 Phase II grouting efforts. These drains were reestablished as point drains, but the relief is only provided at the location of the drain.
